The Road Inventory of Bear Lake National Wildlife Refuge Montpelier, ID

Prepared By:
Federal Highway Administration
Central Federal Lands Highway Division
May 2013

Bear Lake NWR - 14613 Summaries

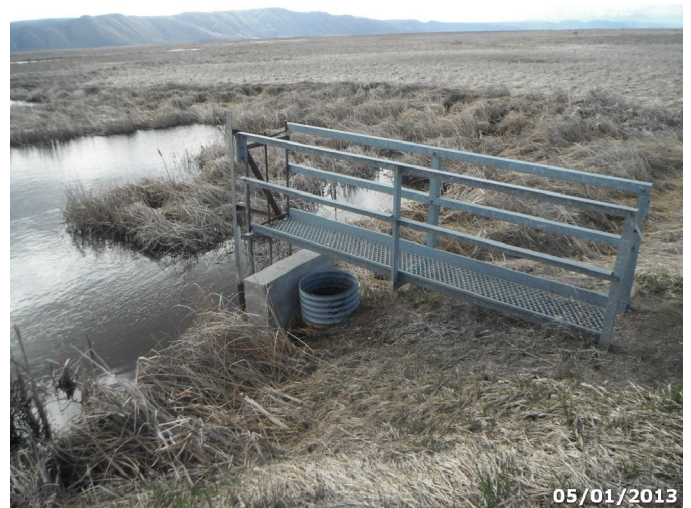
Photo: BELA_C4_0700 Route: 011-001-0.01
Metal WCS Screw Gate 50ft long 36in dia. 4ft deep

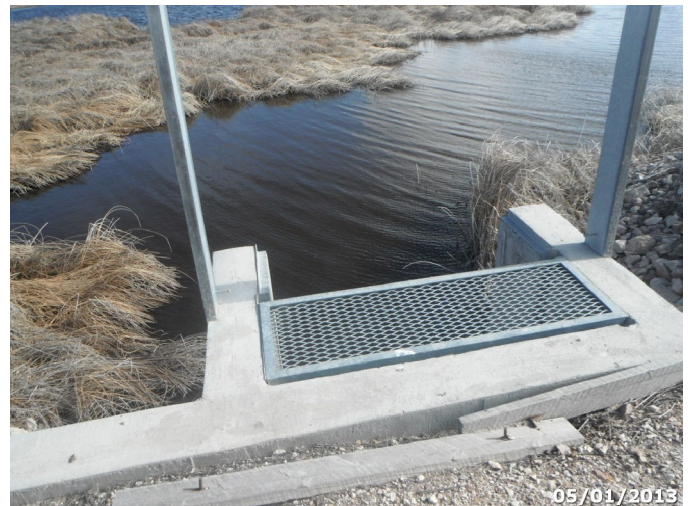
Photo: BELA_C4_0703 Route: 011-001-0.79
Metal WCS Screw Gate 40ft long 48in dia. 4ft deep

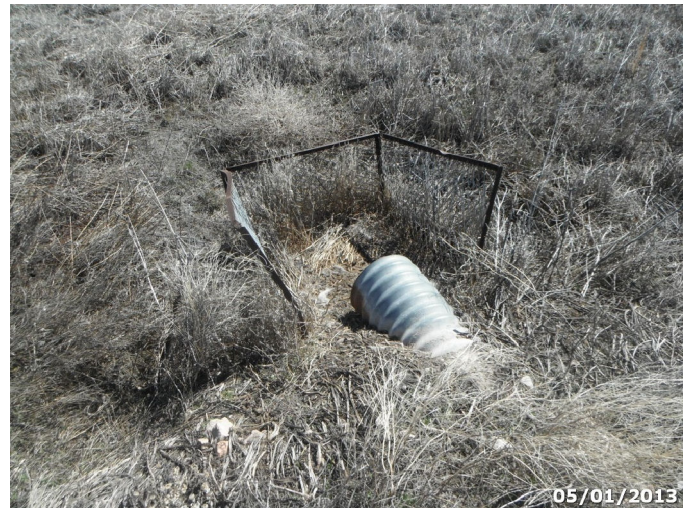
Photo: BELA_C4_0739 Route: 101-001-0.01
Metal Culvert 20ft long 12in dia. 1ft deep

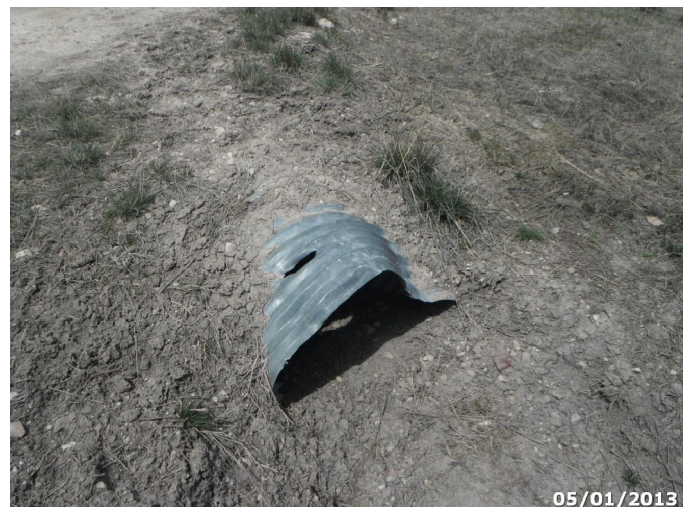
Photo: BELA_C4_0765 Route: 401-002-1.47
Metal Culvert 20ft long 24in dia. 1ft deep

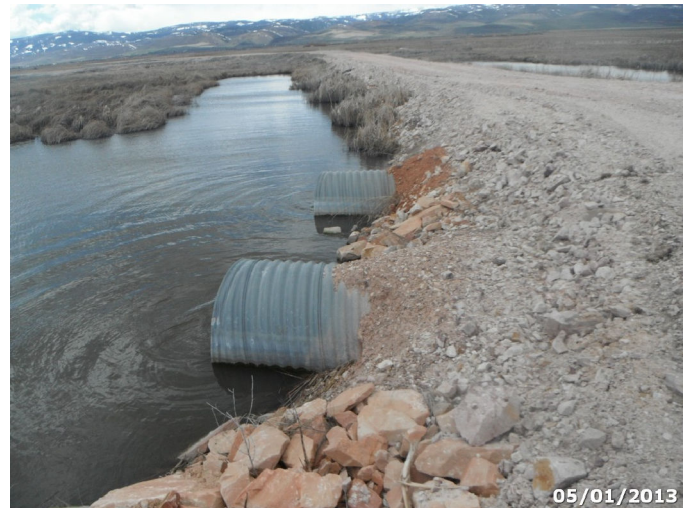
Photo: BELA_C4_0796 Route: 405-001-0.01
2 Metal WCS Flashboard Riser 60ft long 60in dia. 3ft deep

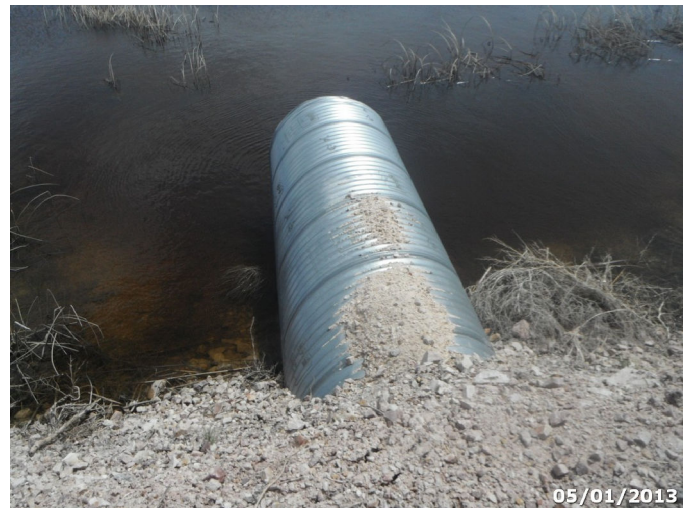
Photo: BELA_C4_0808 Route: 405-001-0.78
Metal Culvert 40ft long 48in dia. 2ft deep
